2012 Historic Preservation Awards Script November 13, 2012 Unity Temple

The Historic Preservation Commission awarded six projects who represent some of the best preservation work in the Village of Oak Park during 2012. The projects range from restoration of missing or damaged features, to the re-use of vacant commercial buildings. We'd like to thank our judges

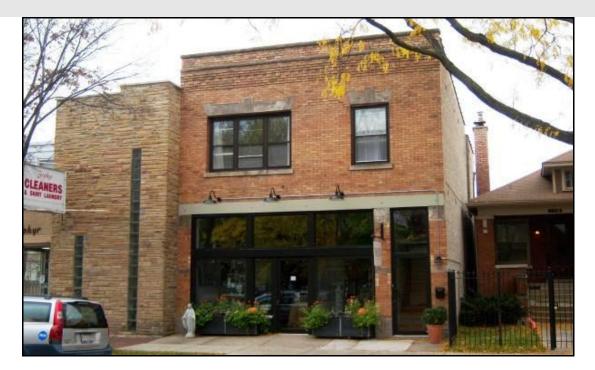
128 CHICAGO AVENUE – REHABILITATION

The building was rehabbed to create the **Bee Home and Garden** store on the first floor and an apartment on the second floor. The project included adding a new roof, new interior kitchens and baths, hardwood floors, and store fixtures, new interior and exterior painting, and a new storefront, signage, and goose-neck lighting. The new design is a architectural appropriate to the historic character of this 107-year old building, while bringing much-need vitality and new life to this under-utilized building on the east end of Chicago Avenue.

The two-story commercial and residential building at 128 Chicago was constructed in 1905. The building had formerly been a small grocery food store and an artist's studio when it was purchased by Colleen Maia in 2011.

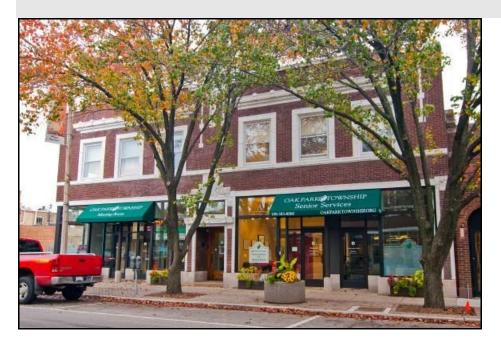
The project also featured a number of sustainable features, including the contribution of useable surplus materials to the ReBuilding Exchange, new insulation and a white roof, use of locally sourced brick, high efficiency heating and cooling, natural ventilation and lighting (photo of cafeteria with new window openings along the alley).....

....lighting control through use sensors, low water flow fixtures, using recycled materials, bicycle parking, and tree preservation instead of expanding parking. The result is an attractive reuse of a prominent historic commercial building in the Avenue Business District.

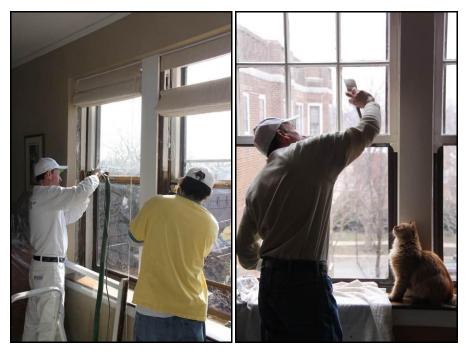
The Condo Board hired **Historic Home and Window Restoration** out of Aurora to begin a window restoration project in the fall of 2011. The windows were in good physical condition, but needed repairs to the glazing putty, sills, and trim. In addition to repainting, the contractor also replaced weatherstripping and broken sash cords, which improved the overall ease of operation and thermal efficiency.

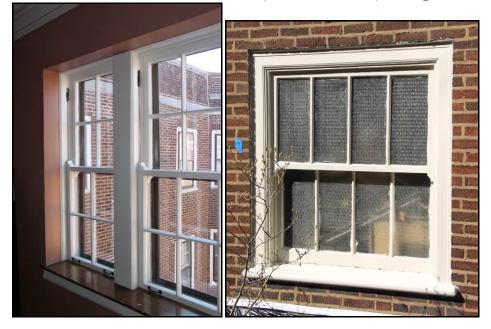
All existing metal storm windows were removed in order to scrape and strip the windows and sills, conduct repair work, then prime and repaint the windows. The storm windows were reinstalled after the work was complete. Individual unit owners determined whether the additional repair and interior painting would be done.

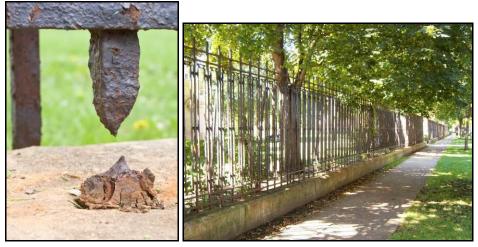
Pleasant Home (John Farson House) was designed in 1897 by architect George Maher in the Prairie Style. It is a National Historic Landmark and Oak Park Historic Landmark. George Maher also designed the steel fence, which is mounted on a limestone plinth supported by a stone foundation, and was completed in 1901. The 110-year old fence and foundation had undergone serious deterioration and required restoration.

The work included careful removal of the fence panels on the north and east sides of the park, and restoration and painting of the panels offsite, including the removal of existing paint, rust and scaling. Midwest Fence then repaired the fence and replaced some deteriorated pickets and other components to match the original. Following stripping and repair, the fence was primed with a zinc-rich primer and painted with a high performance epoxy coating.

The limestone plinth supporting the fence was cleaned and repaired. Sections of the stone foundation required replacement, and the limestone plinth was reset on the foundations using stainless steel dowels to minimize future movement of the fence. Several stone piers were repaired and reset due to shifting, and received new concrete foundations. All mortar matched the original.

Upon completion, the restored steel fence panels were set on the limestone plinth. Existing holes in the plinth were reused and filled with non-shrink grout to securely fasten the fence.

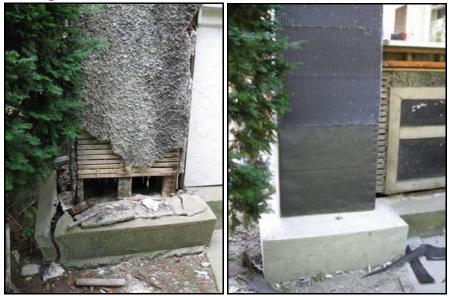
In addition, the front porch stucco columns were repaired by removing deteriorated wood supports, removing cracked concrete footings, pouring new concrete footings, rebuilding new wood supports, and installing new wood and stucco column to match the original stucco texture.

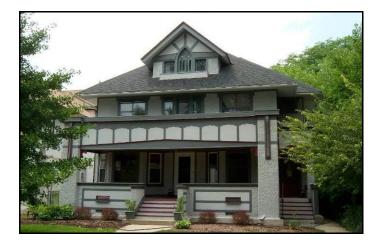
209-211 S. ELMWOOD AVENUE - RESTORATION

The project involved removing all of the aluminum siding off the front façade and front porch of the house and restoring the stucco siding and wood trim based on the original drawings in possession of the owners. This allowed Fortune Restoration to recreate the center dormer window and match the stained glass design of the smaller windows which had been covered.

Finally, stucco on the main house façade required repair, removal and replacement where necessary. New backing was inserted where needed, and all the paint was stripped from the surface. All wood trim and wood windows were stripped and repainted, and all stucco was painted and coated. The result is an incredible transformation not only for the house, but also for the surrounding properties and the block.

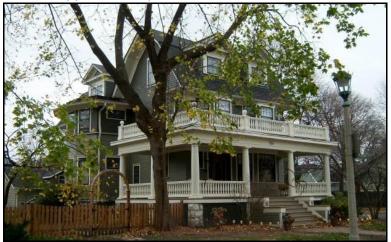
Historic photos were also vital in the design and reconstruction of the original open front porch. All of the wood siding and wood shingles were repaired or replaced as need, stripped and repainted.
